Scour Assessment

Ardersier Port

Client:	Ardersier Port (Scotland) Ltd
Reference:	PC9062-HAS-XX-XX-RP-ME-0001
Status:	S5/P03
Date:	1 October 2026

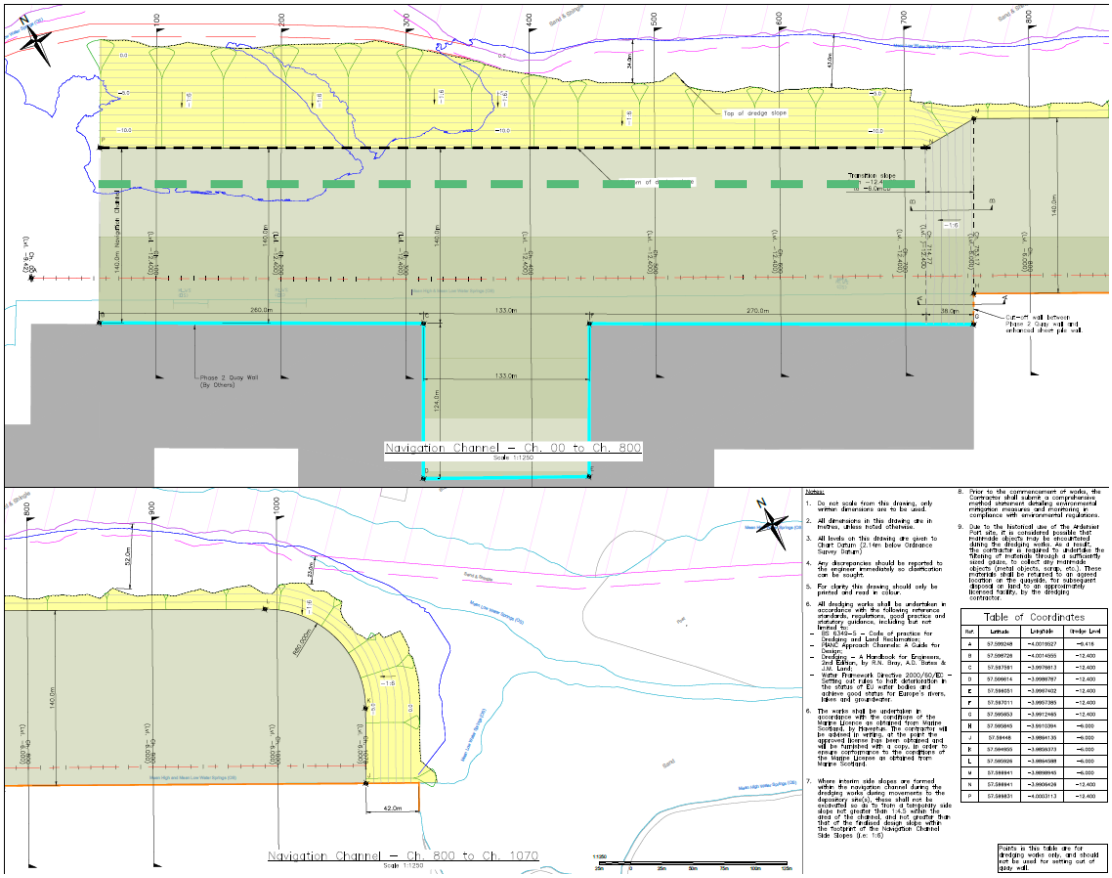
Figure 6-1: Proposed dredged layout, with a dashed green line indicating operational extents for regular manoeuvres

Ardersier Port (Scotland) Limited have provided Haskoning with PDF and CAD versions of the proposed layout post dredging (indicated below). It is reasonable to expect that port operations will endeavour to maintain a healthy margin between vessels and the spit at all times. Comments from Ardersier Port (Scotland) Limited's deputy harbourmaster imply the vessels will not typically have any reason to operate within 30m of the toe of the dredged slope.

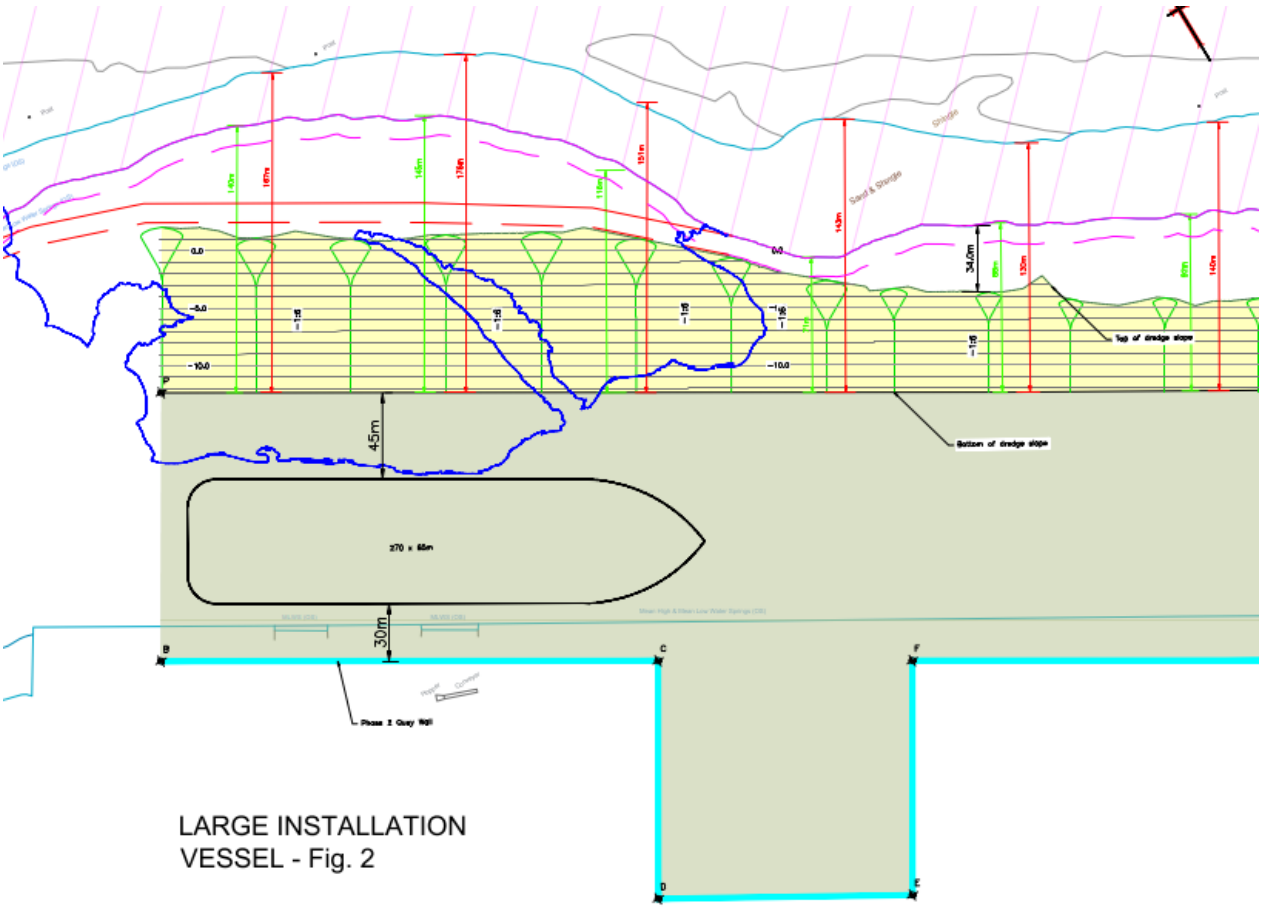
Figure 9-1 Minimum distance to spit for Large Installation Vessel

Figure 9-1 shows the approach configuration advised by the harbourmaster. This indicates that the vessel will align itself no more than 30m from the quayside on its approach. This means that the distance from its props to the toe of the dredge slope is 45m (minimum).

The results demonstrate that for an applied power of 10-20% the expected velocities at the spit are 1.07m/s – 1.8m/s. these velocities exceed the threshold for initiation of motion (0.3-0.35 m/s). Thus, some erosion (especially of loose surface deposits) is expected to occur without any bottom or slope protection. Due to the uncertainties described in Section 5.6.2 it is unclear how much erosion may occur. Therefore, a buffer and monitoring approach is recommended, as described in Section 10.

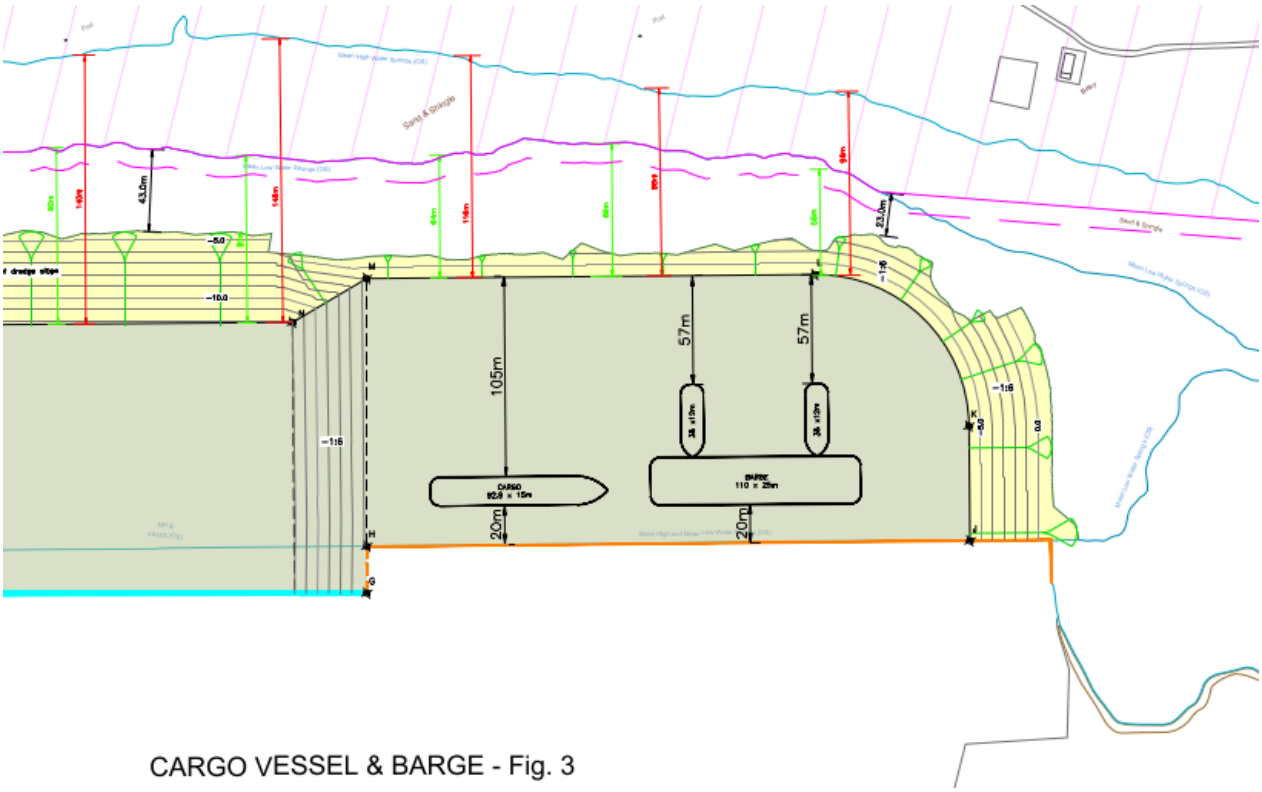
Figure 9-2 Minimum distance to spit for Cargo Vessel and Barge

The maximum size of barge that might enter the Inner Harbour in the -6mCD area is 110m by 25m. These will be tug assisted. Figure 9-2 shows the closest position of such a barge and tugs to the dredge slopes when being pushed onto the berth as being 57m.

The calculation results demonstrate that for an applied power of 10 – 20% the expected velocities at the spit for the case of a tug assisted small vessel are 0.42 – 0.59m/s. Based on these relatively low velocities, only limited erosion (especially of loose surface deposits) is expected to occur if no slope protection is provided. This could be managed with a buffer and monitoring approach, as described in Section 10.
